**Flood Control Project Maintenance  
Levee Inspections**

**Maintenance Issue Types Only, Levee Inspection Report By Mile - Fall 2018**

**Reclamation District No. 0010 Honcut**

Waterway	Bank	Unit Miles	Inspection Start/End	Inspector
Unit No. 01 Simmerly Slough	Right	7.65	10/15/2018 10/15/2018	Sterling York

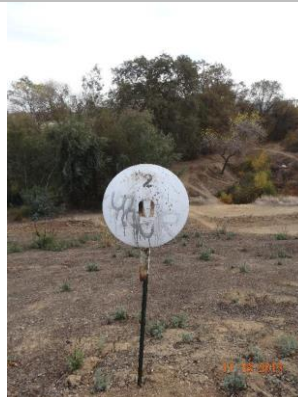
Photo 1 of 3 : UCIP\_FA\_2018\_50058\_51415.jpg

Comment Code						
Inspector Comment						
FS_ID:50058 DS_ID:21258 EP_NO: N/A Repair Type: Non-Urgent Crossing Status: Found UCIP Comments: 7/01/2016 Gate has been repaired--WS gate is functional. LS gate still needs new stem for the gate to properly function--stem is bent. USACE's PI issue references permit number 13710 this is incorrect permit is associated with DS_ID 21259 (CLM 0.767). (DWR UCIP - omagana)4/29/2013 Damaged flap gate on waterward side and damaged stem on screw gate on landward side. Need to contact owner to determine if crossing is still active. If crossing is still in use owner will need to address damage on flap gate and screw gate. If crossing is no longer in use owner will need to contact the CVFPB to comply with Title 23. This crossing is referenced in the USACE Periodic Inspection as item USACE_CESPK_HON1_2013_p_0053 and 0057. (DWR UCIP - omagana) FIELD_STRUCT_DESC: 24-inch corrugated metal gravity drainage pipe through the levee, 31 feet below the crown. Two corrugated metal cutoff walls around pipe. Concrete headwall at each end. Flap gate on the waterside (WS) end. Slide gate on the landside (LS) end. Pipe discharges into 6-foot concrete splash apron on the WS. [Additional Reference(s): DWR Levee Log, 2005. USACE Sacramento O&M Manual 151, May 1953, (Station 46+60)]. FS Date: 7/1/2016

View of WS--Marker indicates crossing is labelled as 2.

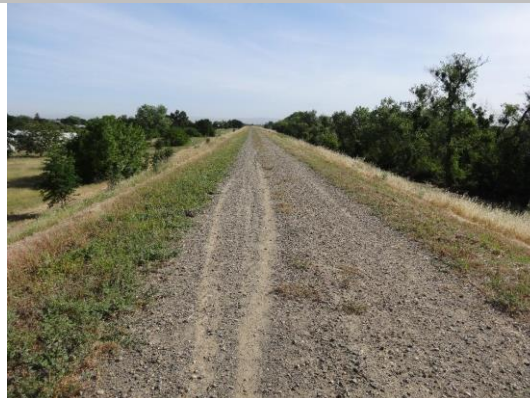
Photo 2 of 3 : UCIP\_FA\_2018\_50058\_51410.jpg

View of levee crown looking downstream.

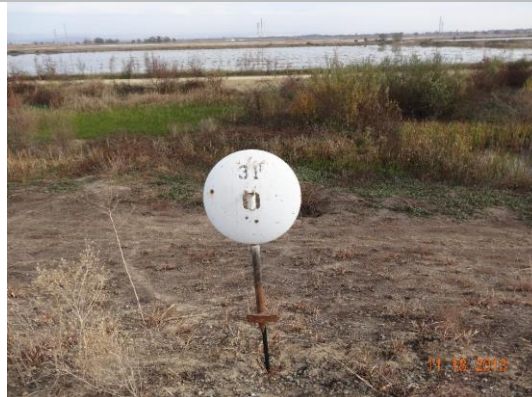
Photo 1 of 3 : UCIP\_FA\_2018\_27746\_51436.jpg

Comment Code						
Inspector Comment						
FS_ID:27746						
DS_ID:21273						
EP_NO: N/A						
Repair Type: No Action Needed						
Crossing Status: Found						
UCIP Comments: 04/29/2013 This crossing is referenced in the						
USACE Periodic Inspection as item						
USACE_CESPK_HON1_2013_p_0217. (DWR UCIP - O. Magana)						
FIELD_STRUCT_DESC: 24-inch reinforced concrete gravity drainage						
pipe through the levee, 19.5 feet below the crown. Flap gate on the						
waterside (WS) end. Concrete headwall at each toe. Concrete saddle						
and apron on the WS. [Additional Reference(s): DWR Levee Log, 2005.						
USACE Sacramento O&M Manual 151, May 1953, (Station 317+80)].						
FS Date: 4/29/2013

View of waterward side--marker for pipe visible on waterward shoulder.

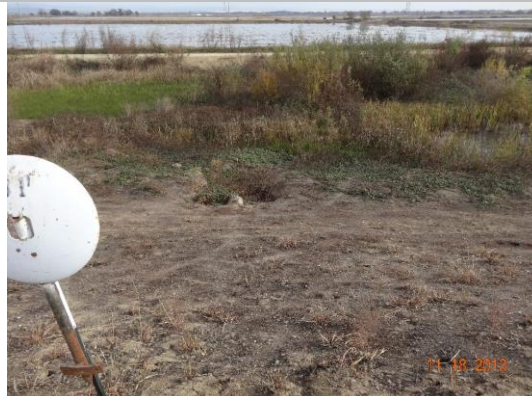
Photo 2 of 3 : UCIP\_FA\_2018\_27746\_51435.jpg

View of pipe on waterward toe.

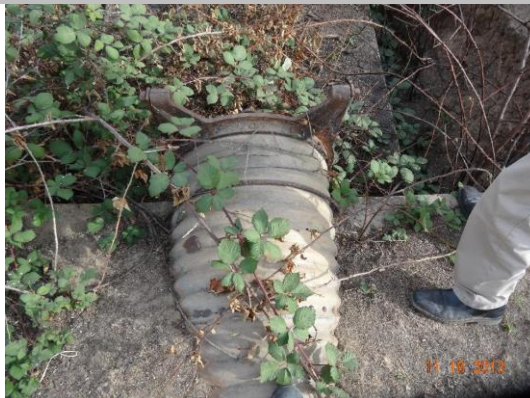
Photo 3 of 3 : UCIP\_FA\_2018\_27746\_51439.jpg

View of pipe, headwall, and concrete apron on waterward toe.

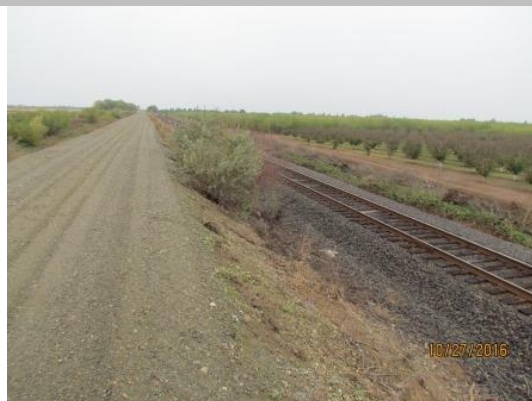
Photo 1 of 1 : FA\_2018\_RD0010\_163\_47\_20180918\_00013.jpg

LM Start	3.93	Rating **	M	Issue No.	47
LM End	3.93	Issue Type +	Ma	Location *	LS
Category	Earthen Levee			GPS Latitude/Longitude	
				Start	End
Item	Trim / Thin Trees			39.202569 °	39.202569 °
				-121.581681 °	-121.581681 °
DWR ID	DWR_RD0010_01_s_2016_47				
Comment Code					
T2 : Thin trees to allow visibility of the ground and room to flood fight.					
Inspector Comment					
Remove small willow tree from levee slope. Fall 2018.

View of a small willow tree that should be removed on the landside looking down stream. Fall 2016.

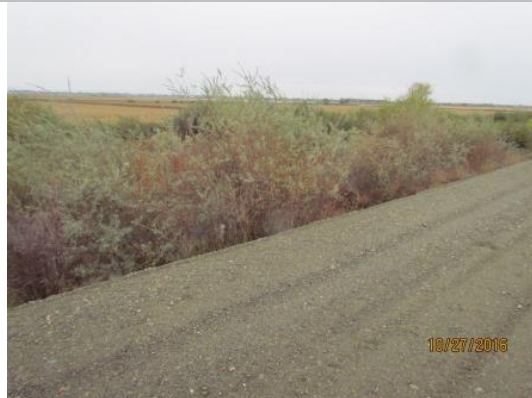
Photo 1 of 1 : FA\_2018\_RD0010\_163\_49\_20180918\_00015.jpg

LM Start	3.93	Rating **	M	Issue No.	49
LM End	3.93	Issue Type +	Ma	Location *	WS
Category	Earthen Levee			GPS Latitude/Longitude	
				Start	End
Item	Trim / Thin Trees			39.202570°	39.202570°
				-121.581681°	-121.581681°
DWR ID	DWR_RD0010_01_s_2016_49				
Comment Code					
T2 : Thin trees to allow visibility of the ground and room to flood fight.					
Inspector Comment					
Remove small willow trees from levee slope. Fall 2018.

View of small starter willow trees on the landside looking upstream. Fall 2016.

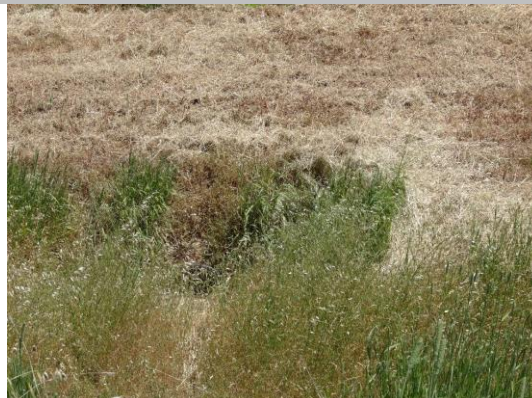
Photo 2 of 3 : UCIP\_FA\_2018\_24438\_43502.jpg

View of waterward toe where pipe daylights.

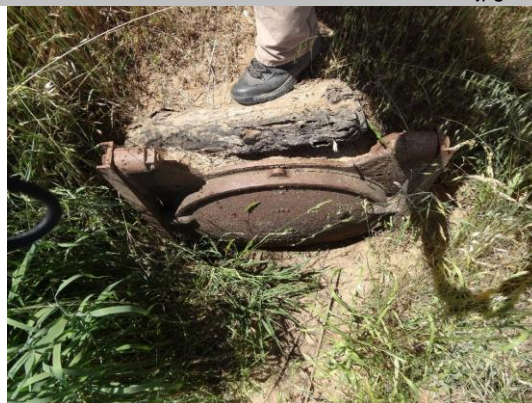
Photo 3 of 3 : UCIP\_FA\_2018\_24438\_43501.jpg

Pipe and flap gate confirmed on waterward side.

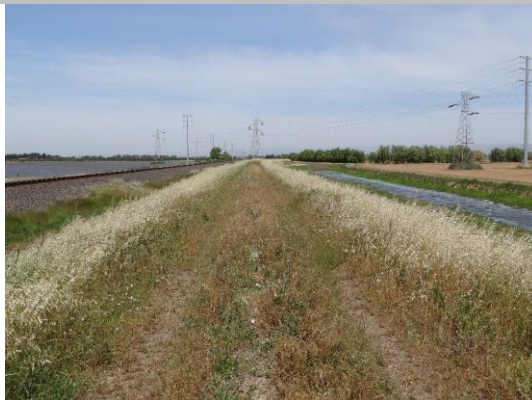
Photo 1 of 3 : UCIP\_FA\_2018\_27532\_51129.jpg

View of levee looking upstream.

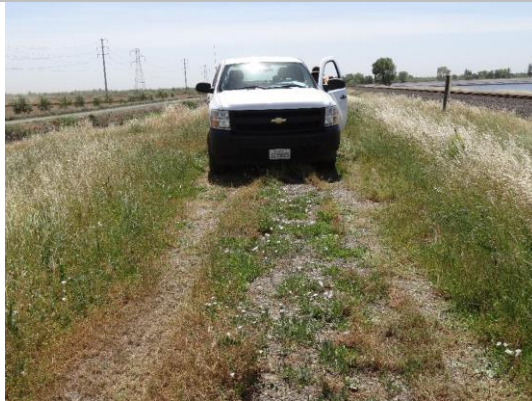
Photo 2 of 3 : UCIP\_FA\_2018\_27532\_51128.jpg

View of levee looking downstream.

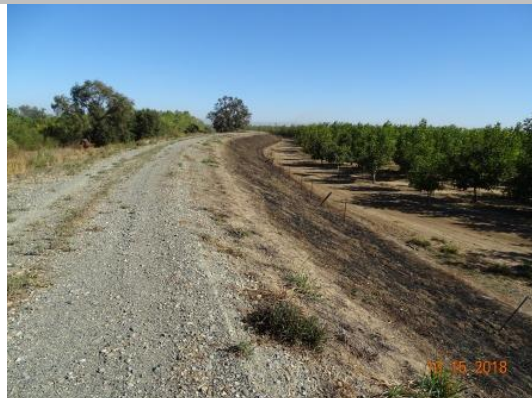
Photo 1 of 1 : FA\_2018\_RD0010\_164\_26\_20181108\_00093.jpg

LM Start	0.02	Rating **	A	Issue No.	26
LM End	11.33	Issue Type +	Ma	Location *	LS
Category	Earthen Levee			GPS Latitude/Longitude	
				Start	End
Item	Vegetation			39.163918 °	39.309619 °
				-121.610058 °	-121.616560 °
DWR ID	DWR_RD0010_02_f_2018_26				
Comment Code					
V1 : Control annual grass and weeds on the levee slopes and easements.					
Inspector Comment					
The annual vegetation is well maintained, Fall 2018.

View looking upstream landside of the well maintained vegetation, Fall 2018.

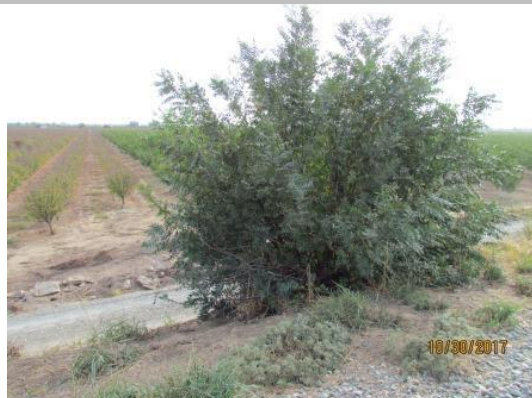
Photo 1 of 1 : FA\_2018\_RD0010\_164\_56\_20180918\_00023.jpg

LM Start	1.16	Rating **	M	Issue No.	56
LM End	1.16	Issue Type +	Ma	Location *	LS
Category	Earthen Levee			GPS Latitude/Longitude	
				Start	End
Item	Trim / Thin Trees			39.180447 °	39.180447 °
				-121.610036 °	-121.610036 °
DWR ID	DWR_RD0010_02_f_2017_56				
Comment Code					
T2 : Thin trees to allow visibility of the ground and room to flood fight.					
Inspector Comment					
Tree less than 4" in diameter needs to be removed, Fall 2018.

View looking downstream landside of a tree less than 4" in diameter that needs to be removed, Fall 2017.

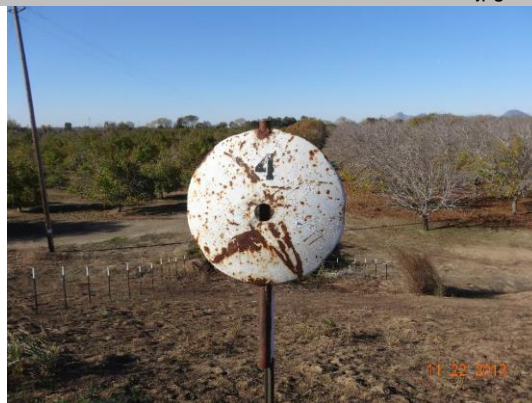
Photo 1 of 3 : UCIP\_FA\_2018\_24821\_44640.jpg

Comment Code					
Inspector Comment					
FS_ID:24821 DS_ID:21281 EP_NO: N/A Repair Type: Non-Urgent Crossing Status: Found UCIP Comments: 04/30/2013 Screw gate on landward side is blocked by sediment. Recommend removing sediment in front of gate. This crossing is referenced in the USACE Periodic Inspection as item USACE_CESPK_HON2_2013_p_0082. (DWR UCIP - O. Magana) FIELD_STRUCT_DESC: 24-inch corrugated metal gravity drainage pipe through the levee, 26 feet below the crown. Corrugated metal cutoff wall around the pipe at each shoulder. Flap gate on the waterside (WS) end. Slide gate on the landside (LS) end. Concrete headwall, saddle, and apron on the WS end. [Additional Reference(s): DWR Levee Log, 2005. USACE Sacramento O&M Manual 151, May 1953, (Station 149+88)]. FS Date: 4/30/2013

Marker visible on waterward side--No. 4.

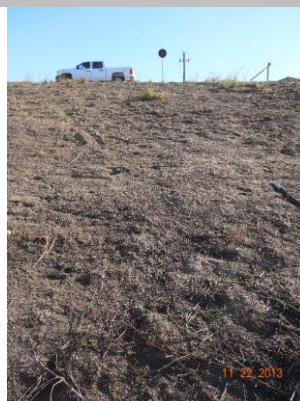
Photo 2 of 3 : UCIP\_FA\_2018\_24821\_44639.jpg

View of waterward slope side.

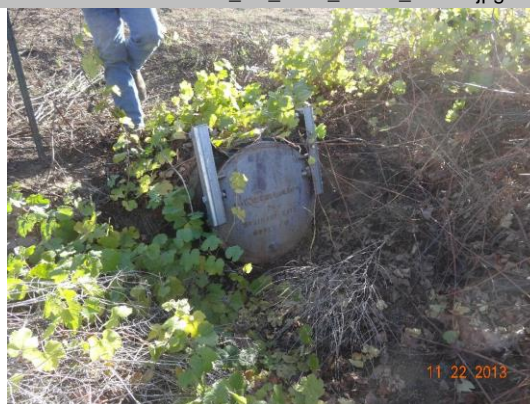
Photo 3 of 3 : UCIP\_FA\_2018\_24821\_44638.jpg

View of flap gate located on waterward side.

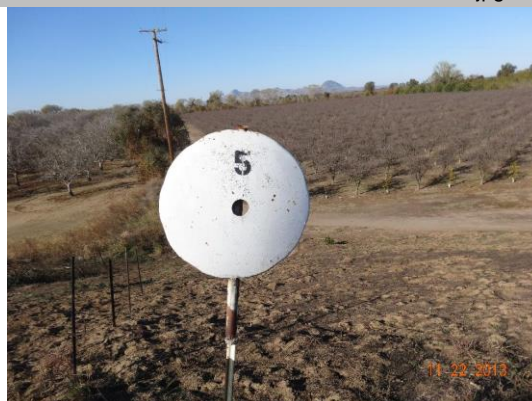
Photo 1 of 3 : UCIP\_FA\_2018\_24822\_44647.jpg

Marker visible on waterward side--No. 5.

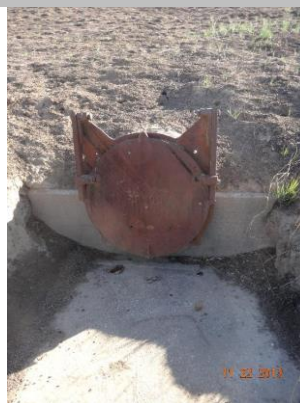
Photo 3 of 3 : UCIP\_FA\_2018\_24822\_44645.jpg

View of flap gate on waterward side.

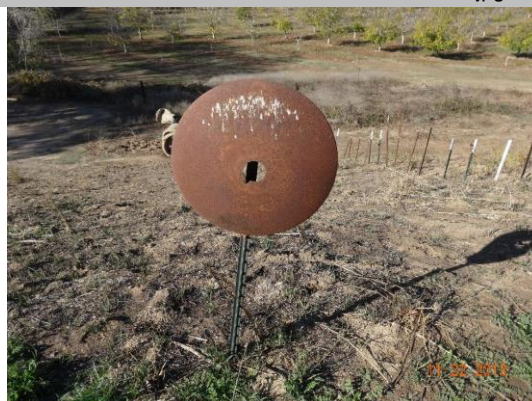
Photo 1 of 3 : UCIP\_FA\_2018\_52889\_44658.jpg

Comment Code						
Inspector Comment						
FS_ID:52889						
DS_ID:21284						
EP_NO: N/A						
Repair Type: Non-Urgent						
Crossing Status: Found						
UCIP Comments: 04/30/2013 Remove concrete piece preventing complete closure of screw gate on landward side. This crossing is referenced in the USACE Periodic Inspection as item USACE_CESPK_HON2_2013_p_0152. (DWR UCIP - O. Magana)						
FIELD_STRUCT_DESC: 36-inch corrugated metal gravity drainage pipe through the levee, 24 feet below the crown. Corrugated metal cutoff wall around the pipe at each shoulder. Flap gate on the waterside (WS) end. Slide gate on the landside (LS) end. Concrete headwall at each end.						
[Additional Reference(s): DWR Levee Log, 2005. USACE Sacramento O&M Manual 151, May 1953, (Station 259+76)].						
FS Date: 4/30/2013

Marker visible on waterward side.

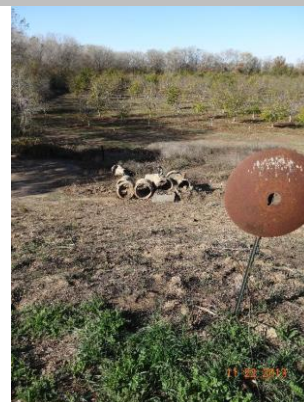
Photo 2 of 3 : UCIP\_FA\_2018\_52889\_44657.jpg

Overview of waterward slope--barrier placed at toe to discourage damage to crossing.

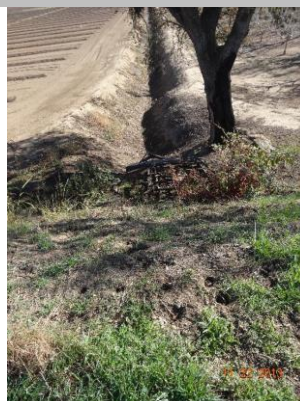
Photo 3 of 3 : UCIP\_FA\_2018\_52889\_44656.jpg

View of landward side--barrier used to discourage damage to crossing near toe.

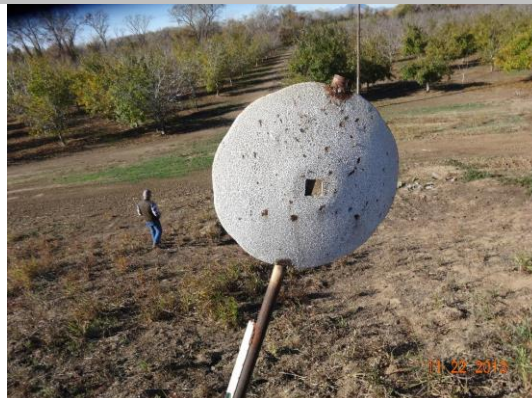
Photo 1 of 3 : UCIP\_FA\_2018\_24825\_44664.jpg

Comment Code					
Inspector Comment					
FS_ID:24825 DS_ID:21285 EP_NO: N/A Repair Type: Non-Urgent Crossing Status: Found UCIP Comments: 04/30/2013 Sediment blocking flap gate and screw gate--recommend removing material. Dense burrow activity present along levee slopes (large holes visible on landward side)--recommend addressing issue. This crossing is referenced in the USACE Periodic Inspection as item USACE_CESPK_HON2_2013_p_0169. (DWR UCIP - O. Magana) FIELD_STRUCT_DESC: 30-inch corrugated metal gravity drainage pipe through the levee, 19.5 feet below the crown. Corrugated metal cutoff wall around the pipe at each shoulder. Flap gate on the waterside (WS) end. Slide gate on the landside (LS) end. Concrete headwall at each end. [Additional Reference(s): DWR Levee Log, 2005. USACE Sacramento O&M Manual 151, May 1953, (Station 277+00)]. FS Date: 4/30/2013

Marker visible on waterward side.

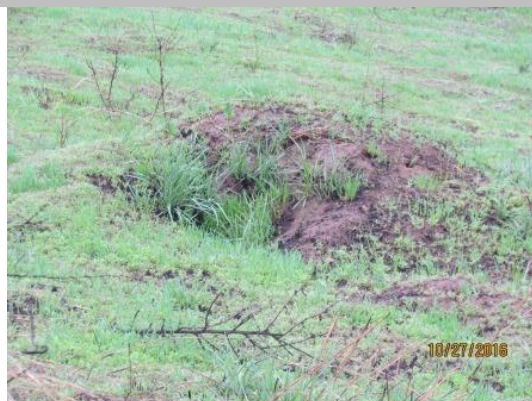
Photo 1 of 1 : FA\_2018\_RD0010\_164\_33\_20180918\_00009.jpg

LM Start	6.88	Rating **	U	Issue No.	33
LM End	6.88	Issue Type +	Ma	Location *	WS
Category	Earthen Levee			GPS Latitude/Longitude	
				Start	End
Item	Animal Control			39.259843 °	39.259843 °
				-121.616013 °	-121.616013 °
DWR ID	DWR_RD0010_02_f_2015_33				
Comment Code					
A3 : No rodents visible, but rodent burrows visible; need to backfill and compact or grout burrows.					
Inspector Comment					
Rodent hole that has more than 2 cubic feet of material, this hole is not active but needs to be backfilled properly, Fall 2018.

View of rodent hole that has more than 2 cubic feet of material, this hole is not active but needs to be backfilled properly.

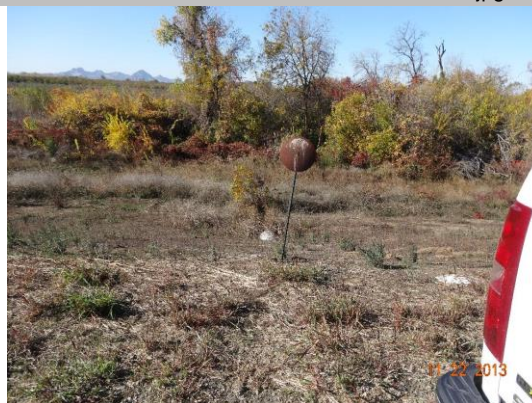
Photo 1 of 3 : UCIP\_FA\_2018\_24831\_44700.jpg

Visible marker located on waterward shoulder--no id number noted.

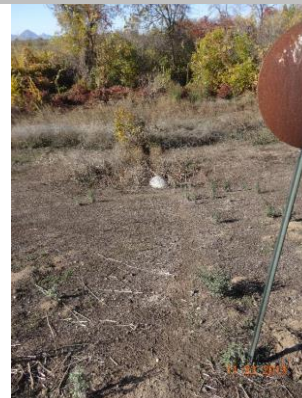
Photo 2 of 3 : UCIP\_FA\_2018\_24831\_44699.jpg

View of waterward slope.

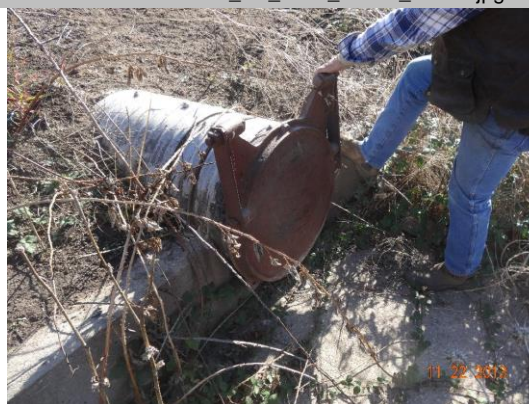
Photo 3 of 3 : UCIP\_FA\_2018\_24831\_44698.jpg

Flap gate visible on waterward side.

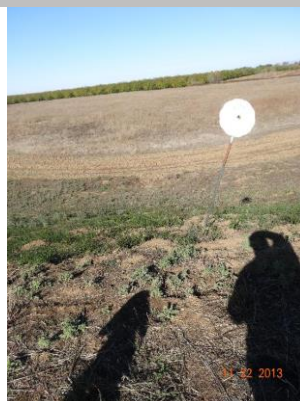
Photo 1 of 3 : UCIP\_FA\_2018\_27775\_51473.jpg

Comment Code						
Inspector Comment						
FS_ID:27775						
DS_ID:21296						
EP_NO: N/A						
Repair Type: Non-Urgent						
Crossing Status: Found						
UCIP Comments: 04/30/2013 Sediment build-up at the inlet--						
recommend clearing sediment. This crossing is referenced in the						
USACE Periodic Inspection as item						
USACE_CESPK_HON2_2013_p_0348. (DWR UCIP - O. Magana)						
FIELD_STRUCT_DESC: 30-inch corrugated metal gravity drainage pipe						
through the levee, 23 feet below the crown. Corrugated metal cutoff wall						
around the pipe at each shoulder. Flap gate on the waterside (WS) end.						
Slide gate on the landside (LS) end. Concrete headwall at each end.						
Metal marker on the WS shoulder. [Additional Reference(s): DWR						
Levee Log, 2005. USACE Sacramento O&M Manual 151, May 1953,						
(Station 551+96)].						
FS Date: 4/30/2013

View of waterward side.

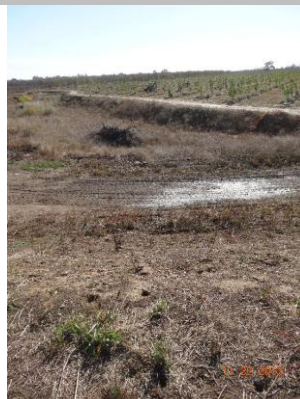
Photo 2 of 3 : UCIP\_FA\_2018\_27775\_51472.jpg

View of landward side.

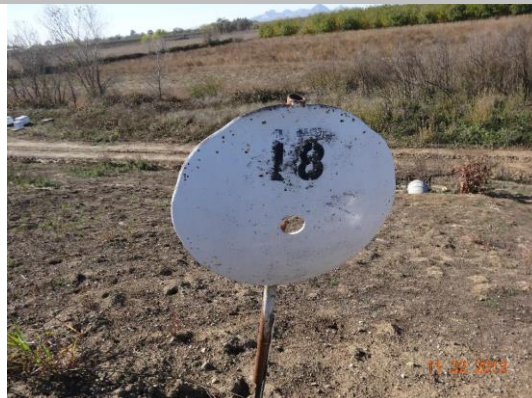
Photo 1 of 3 : UCIP\_FA\_2018\_24834\_44715.jpg

Comment Code						
Inspector Comment						
FS_ID:24834						
DS_ID:21297						
EP_NO: N/A						
Repair Type: Non-Urgent						
Crossing Status: Found						
UCIP Comments: 04/30/2013 Slide gate missing on landward side.						
Need to contact owner to determine status of crossing. This crossing is						
referenced in the USACE Periodic Inspection as item						
USACE_CESPK_HON2_2013_p_0367. (DWR UCIP - O. Magana)						
FIELD_STRUCT_DESC: 24-inch corrugated metal gravity drainage pipe						
through the levee, 14 feet below the crown. Corrugated metal cutoff wall						
around the pipe at each shoulder. Flap gate on the waterside (WS) end.						
Slide gate on the landside (LS), slide gate missing. Concrete headwall,						
saddle, and apron on the WS end. 6-foot by 6-foot concrete splash						
apron at the WS toe. [Additional Reference(s): DWR Levee Log, 2005.						
USACE Sacramento O&M Manual 151, May 1953, (Station 565+74)].

Marker visible on waterward shoulder, crossing is referenced as No. 18.

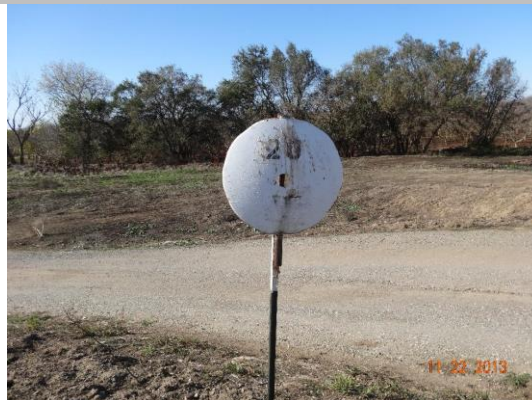
Photo 1 of 3 : UCIP\_FA\_2018\_24769\_44454.jpg

Comment Code					
Inspector Comment					
FS_ID:24769 DS_ID:21299 EP_NO: N/A Repair Type: Non-Urgent Crossing Status: Found UCIP Comments: 04/30/2013 Need to contact owner. Need to clear debris from concrete distribution box on waterward and remove debris blocking landward side.This crossing is referenced in the USACE Periodic Inspection as item USACE_CESPK_HON2_2013_p_0383. (DWR UCIP - O. Magana) FIELD_STRUCT_DESC: 24-inch corrugated metal gravity drainage pipe through the levee, 12 feet below the crown. Corrugated metal cutoff wall around the pipe at each shoulder. Flap gate on the waterside (WS) end. Slide gate on the landside (LS). Concrete headwall, saddle, and apron on the WS end. Metal marker on the WS shoulder. [Additional Reference(s): DWR Levee Log, 2005. USACE Sacramento O&M Manual 151, May 1953, (Station 582+72)]. FS Date: 4/30/2013

Marker visible on waterward side shoulder, crossing is referenced as No. 20.

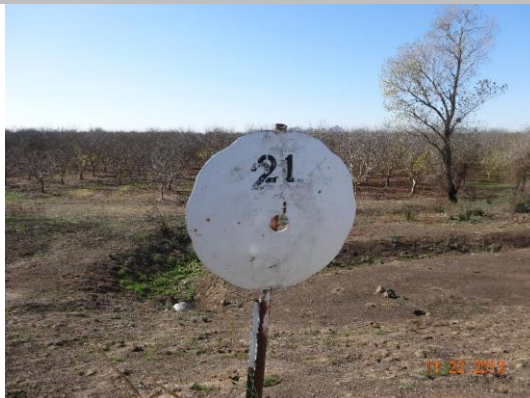
Photo 1 of 3 : UCIP\_FA\_2018\_24835\_44721.jpg

Marker visible on waterward shoulder, crossing referenced as No. 21.

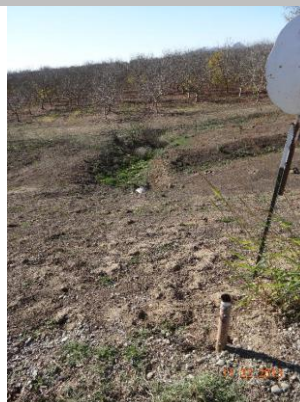
Photo 2 of 3 : UCIP\_FA\_2018\_24835\_44720.jpg

View of waterward side.

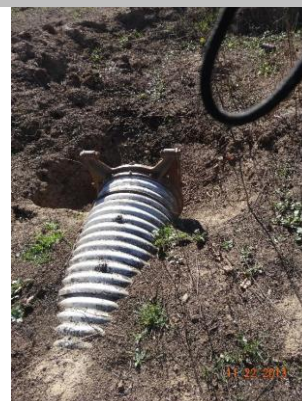
Photo 3 of 3 : UCIP\_FA\_2018\_24837\_44734.jpg

Pipe through waterside side.

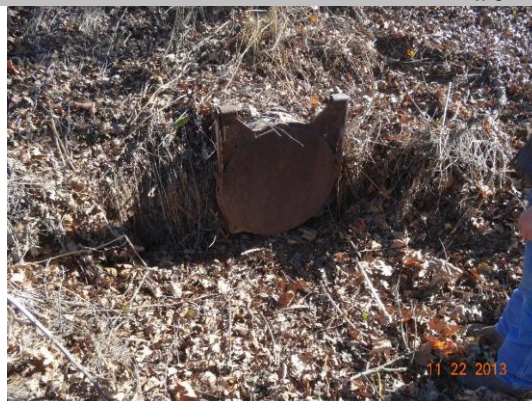
Photo 2 of 3 : UCIP\_FA\_2018\_24840\_44752.jpg

View of flap gate located on waterward side.

Comment Code						
Inspector Comment						
FS_ID:24840 DS_ID:21305 EP_NO: N/A Repair Type: Non-Urgent Crossing Status: Found UCIP Comments: 04/30/2013 Burrow activity--large holes found on landward side. Crossing on landward side is blocked. Recommend clearing headwall and crossing. Need to coordinate with owner to determine status of crossing. If crossing is no longer in use owner will need to contact the CVFPB to comply with Title 23. This crossing is referenced in the USACE Periodic Inspection as item USACE_CESPK_HON2_2013_p_0476. (DWR UCIP - O. Magana) FIELD_STRUCT_DESC: 24-inch corrugated metal gravity drainage pipe through the levee, 7.5 feet below the crown. Corrugated metal cutoff wall around the pipe at each shoulder. Flap gate on the waterside (WS) end. Concrete headwall at each toe. Saddle and apron on the WS. [Additional Reference(s): DWR Levee Log, 2005. USACE Sacramento O&M Manual 151, May 1953, (Station 674+73)]. FS Date: 4/30/2013

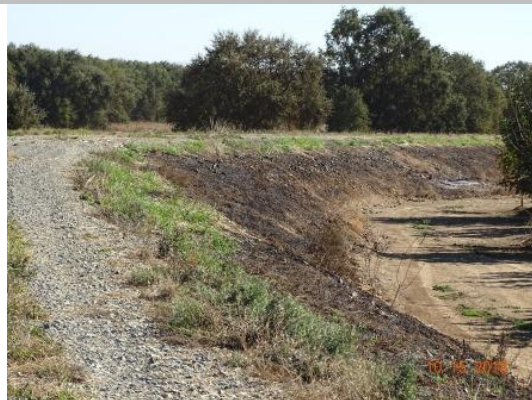
Photo 1 of 1 : FA\_2018\_RD0010\_165\_4\_20181108\_00014.jpg

LM Start	0.34	Rating **	A	Issue No.	4
LM End	2.80	Issue Type +	Ma	Location *	LS
Category	Earthen Levee			GPS Latitude/Longitude	
				Start	End
Item	Vegetation			39.310249 °	39.298557 °
				-121.610003 °	-121.569981 °
DWR ID	DWR_RD0010_03_f_2018_4				
Comment Code					
V1 : Control annual grass and weeds on the levee slopes and easements.					
Inspector Comment					
The annual vegetation is well maintained, Fall 2018.

View looking upstream landside at the well maintained vegetation, Fall 2018.

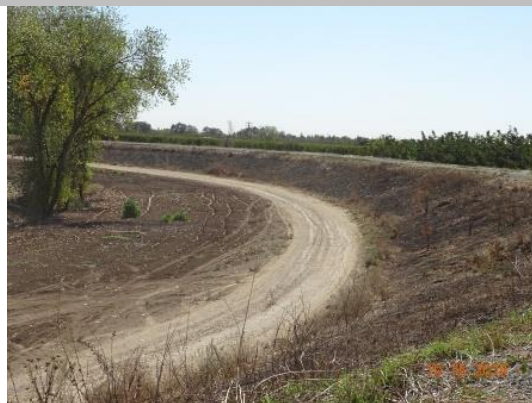
Photo 1 of 1 : FA\_2018\_RD0010\_165\_9\_20181108\_00017.jpg

LM Start	0.60	Rating **	A	Issue No.	9
LM End	2.80	Issue Type +	Ma	Location *	WS
Category	Earthen Levee			GPS Latitude/Longitude	
				Start	End
Item	Vegetation			39.310184°	39.298557°
				-121.605206°	-121.569981°
DWR ID	DWR_RD0010_03_f_2018_9				
Comment Code					
V1 : Control annual grass and weeds on the levee slopes and easements.					
Inspector Comment					
The annual vegetation is well maintained, Fall 2018.

View looking upstream waterside at the well maintained vegetation, Fall 2018.

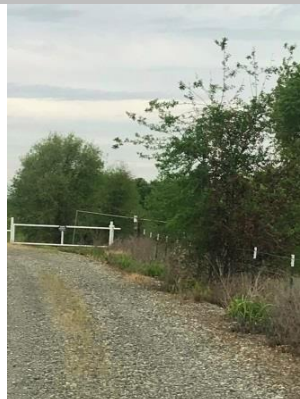
Photo 1 of 1 : FA\_2018\_RD0010\_165\_10\_20180918\_00004.jpg

LM Start	1.10	Rating **	M	Issue No.	10
LM End	1.10	Issue Type +	Ma	Location *	WS
Category	Earthen Levee			GPS Latitude/Longitude	
				Start	End
Item	Trim / Thin Trees			39.306995 °	39.306995 °
				-121.597116 °	-121.597116 °
DWR ID	DWR_RD0010_03_s_2018_10				
Comment Code					
T2 : Thin trees to allow visibility of the ground and room to flood fight.					
Inspector Comment					
Tree needs to be trimmed for access and visibility, Spring 2018.

View looking downstream waterside of a tree that needs to be trimmed for access and visibility, Spring 2018.

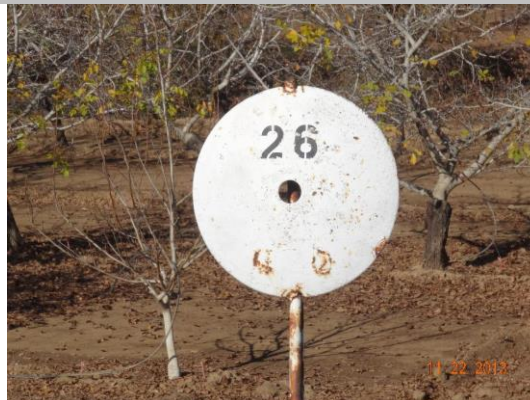
Photo 1 of 3 : UCIP\_FA\_2018\_24842\_44764.jpg

Comment Code						
Inspector Comment						
FS_ID:24842						
DS_ID:21307						
EP_NO: N/A						
Repair Type: Non-Urgent						
Crossing Status: Found						
UCIP Comments: 05/01/2013 Sediment deposit inside pipe--Need to coordinate with owner to determine status of crossing. If crossing is no longer in use owner will need to contact the CVFPB to comply with Title 23. (DWR UCIP - O. Magana)						
FIELD_STRUCT_DESC: 24-inch corrugated metal gravity drainage pipe through the levee, 15 feet below the crown. Corrugated metal cutoff wall around the pipe at each shoulder. Flap gate on the waterside (WS) end. Slide gate on the landside (LS) end. Concrete headwall at each toe.						
[Additional Reference(s): DWR Levee Log, 2005. USACE Sacramento O&M Manual 151, May 1953, (Station 134+06)].						
FS Date: 5/1/2013

Marker visible on waterward side--No. 26.

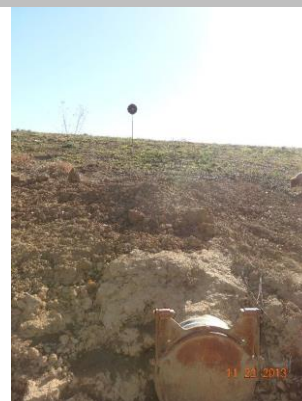
Photo 2 of 3 : UCIP\_FA\_2018\_24842\_44762.jpg

Comment Code						
Inspector Comment						
FS_ID:24842						
DS_ID:21307						
EP_NO: N/A						
Repair Type: Non-Urgent						
Crossing Status: Found						
UCIP Comments: 05/01/2013 Sediment deposit inside pipe--Need to coordinate with owner to determine status of crossing. If crossing is no longer in use owner will need to contact the CVFPB to comply with Title 23. (DWR UCIP - O. Magana)						
FIELD_STRUCT_DESC: 24-inch corrugated metal gravity drainage pipe through the levee, 15 feet below the crown. Corrugated metal cutoff wall around the pipe at each shoulder. Flap gate on the waterside (WS) end. Slide gate on the landside (LS) end. Concrete headwall at each toe.						
[Additional Reference(s): DWR Levee Log, 2005. USACE Sacramento O&M Manual 151, May 1953, (Station 134+06)].						
FS Date: 5/1/2013

View of waterward slope.

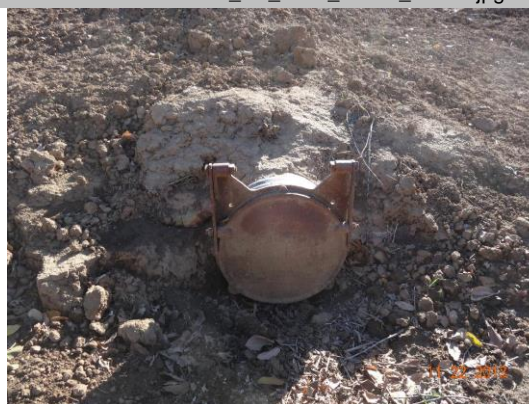
Photo 3 of 3 : UCIP\_FA\_2018\_24842\_44763.jpg

View of flap gate located on waterward side.
